U 47 Modifications & Colours

Dougie Martindale
Accurate Model Parts

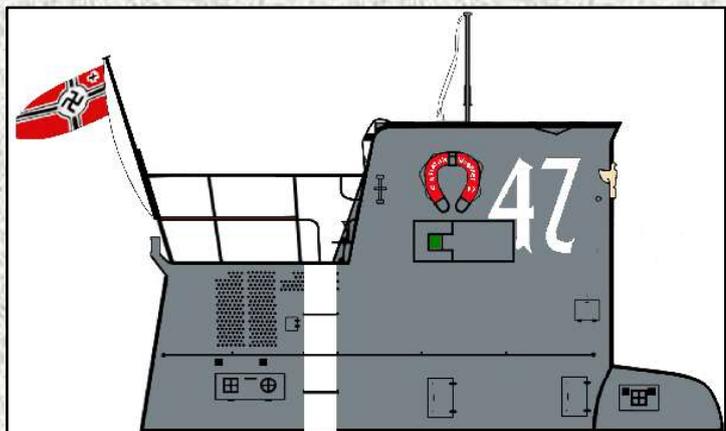
Right (1): The starboard side of the original tower of U 47 at the start of the U-boat's career on the 17th December 1938. The pre-war features on the tower are the identification number, red lifebelt and bronze eagle at the front of the tower. The vertical board behind the rungs was in place only on this date, the day of the commissioning ceremony, so that the pristine paintwork would not be smudged by the tips of sailors' dirty boots.

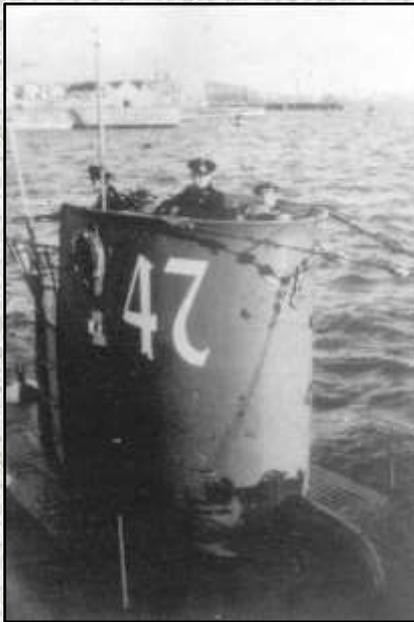
Left (2): A number of pre-war features are evident in this photo of U 47 during her *Indienststellung* (commissioning ceremony) on the 17th December 1938. The paint is fresh since all U-boats received a fresh coat of paint for their commissioning ceremony. Note that there was no spray deflector midway up the front of the conning tower at this time.

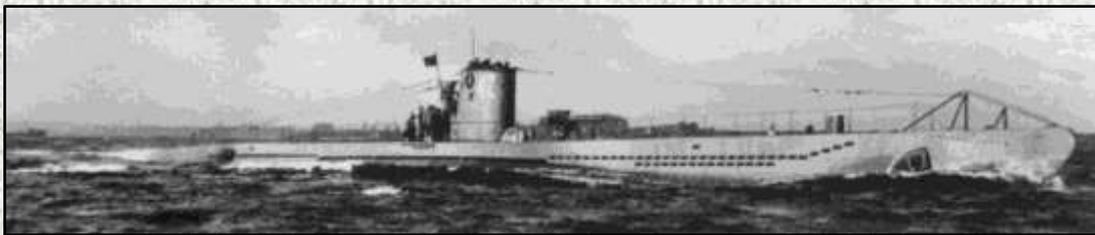
Below (3): U 47 in 1939 with a net cutter. At some point in 1939 when U 47 sailed past Gibraltar the boat did not have a net cutter. This was reintroduced prior to hostilities.

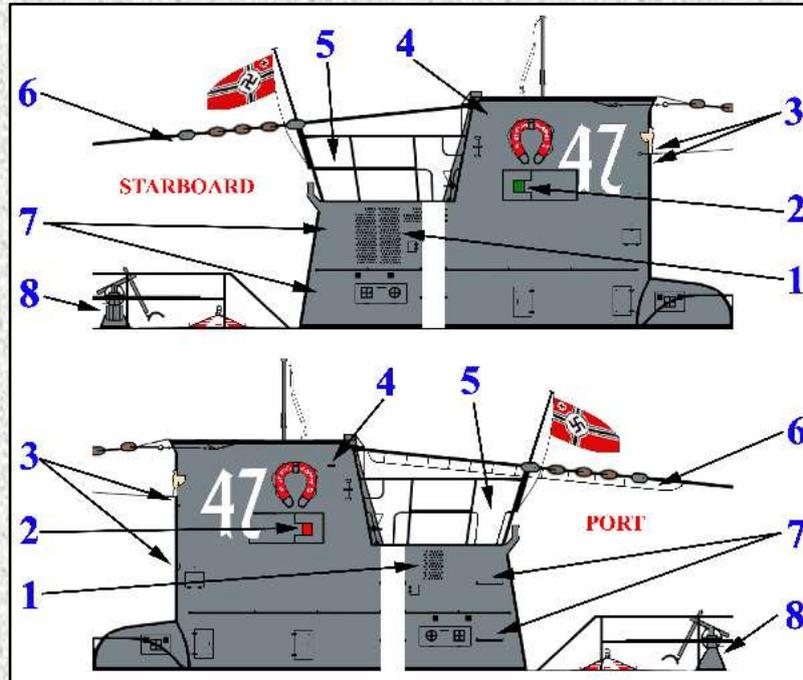
Above (4): This drawing illustrates the differences between either side of the original tower of U 47. The numbers indicate the following differences: 1 ventilation holes; 2 navigation light colour; 3 aerial and foghorn holes; 4 clip; 5 tower railings; 6 extra wires; 7 rungs; 8 cartridge tray.

During 1938 and 1939, the tower railings and their seats were not symmetrical on either side. In photographs taken from the port side, the parts of the starboard railings and starboard seat that did not have a symmetrical equivalent on the port side are visible. In order to avoid confusion, and illustrate the difference between the port and starboard railings and seats, only the sections of the railings and seat which were located on the port side are shown on the port drawing, and only the sections of the railings and seat which were located on the starboard side are shown on the starboard drawing.

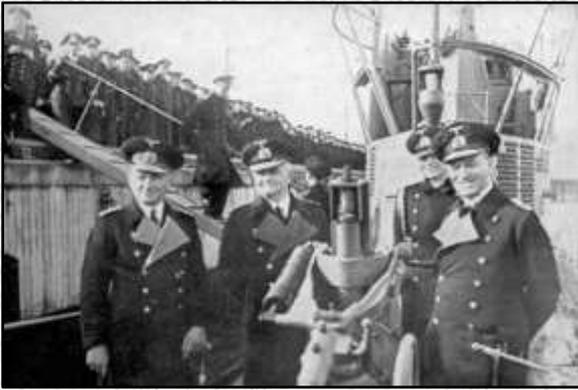
Left (5): A comparison can be made between the tower railings and ventilation holes on either side of U 47's tower in this photo, taken at Wilhelmshaven on the 17th October 1939.

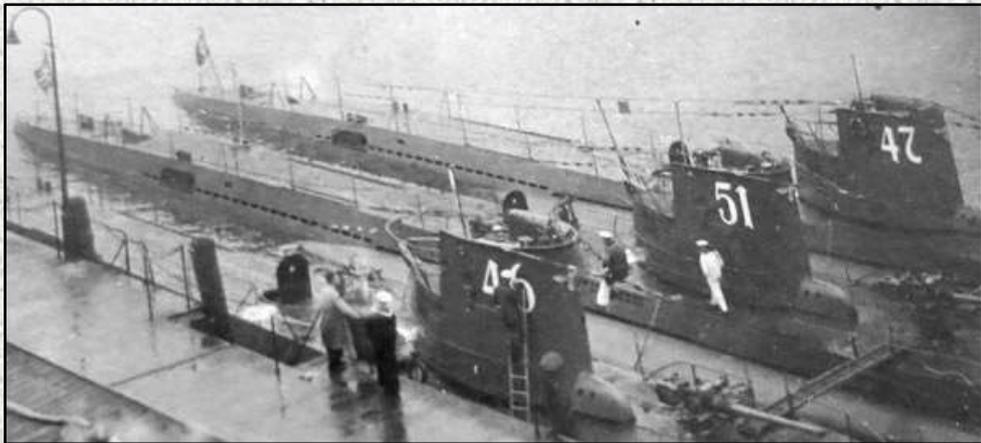
Below (7): The three VIIBs look dark in this and a few other pre-war shots; it may be that the upper hull and tower of U 47 was a darker grey for a period during 1939. The dark patch surrounding the diesel exhaust outlet can be seen on U 47 and U 51. The dirty exhaust gases tended to blacken the paintwork around the outlet. During the pre-war period this area around the outlet was painted dark grey or black to disguise this weathering. By wartime this practice was generally discontinued.

During the pre-war period, the U-bootwaffe experimented with several paint colours on the upper hull and conning towers. In addition to *Dunkelgrau 51* - the most common of the Kriegsmarine paints - darker shades of grey were also used. The *Dunkelgrau 52* (RAL7024) paint was probably used on some U-boats. This darkish neutral grey was a little lighter than the dark grey *Schiffsbodenfarbe III Grau* used on the lower hull. Some of the pre-war shots of U 47 show a dark upper hull and conning tower. It may be that U 47 was painted for some pre-war periods in a grey that was darker than the standard *Dunkelgrau 51*.

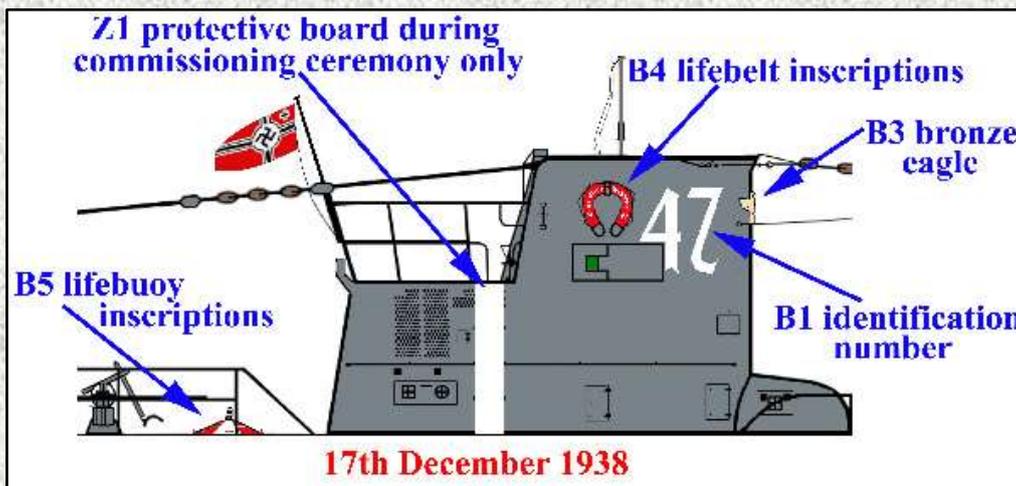
Above (8): This drawing shows some of the features on the boat during commissioning that were removed prior to hostilities.

- the large white 47 was painted over with *Dunkelgrau 51* paint (B1).
- the oval bow plates were removed (B2).
- the bronze eagle plaque was removed (B3).
- the identification markings on the lifebelts (B4) and lifebuoys (B5) were painted over.

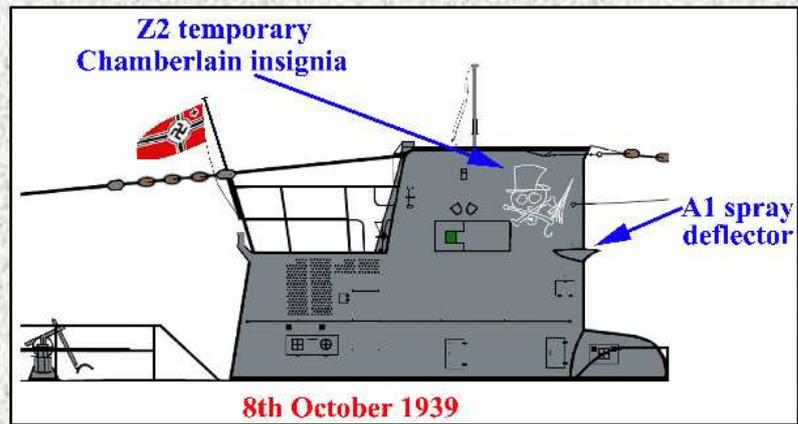
Above (9): Before U 47’s departure on the Scapa Flow mission, a temporary drawing mocking the British Prime Minister Neville Chamberlain appeared on the tower. The pre-war features are no longer present, while the tower now has a small spray deflector midway up the tower.

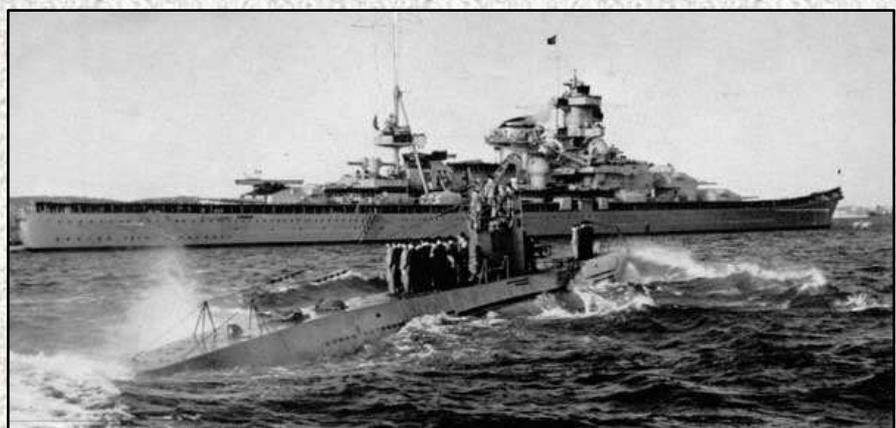
Below (10): The famous photo of U 47 sailing in front of the *Scharnhorst*. The colour of U 47 looks very similar to the *Dunkelgrau 51* hull of the warship.

Notably, in many photos of U 47 available from October 1939, only a couple show the U-boat looking light in shade. In the majority of photos, U 47’s upper colour looks similar to *Dunkelgrau 51*. What is required is a photograph showing U 47 next to, or in the vicinity of, a warship or U-boat tender. The *Hellgrau 50* superstructures and *Dunkelgrau 51* upper hulls of these vessels would provide reference points with which to gauge the colour of U 47’s upper hull and conning tower. Good quality images of the famous photo taken on the 23rd October 1939 of U 47 passing by the battleship *Scharnhorst* provide us with just such an opportunity. In this photo, U 47 is very similar to the battleship’s *Dunkelgrau 51* hull, and much darker than the battleship’s *Hellgrau 50* superstructure. The photo of U 47 sailing past the training ship *Schleswig-Holstein* on the 23rd October 1939 suggests the same.

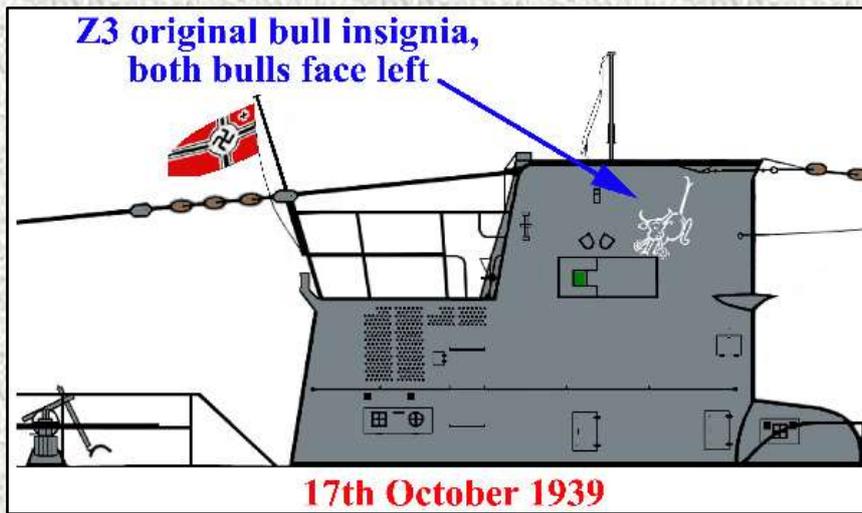
Above (11): When U 47 returned from the Scapa Flow on the 17th October 1939, the tower was adorned with the original Bull Of Scapa Flow insignia. For more details please refer to the AMP article *The Snorting Bull Insignia*.

Several photographs taken of U 47 between the 17th and the 24th October 1939 show that the U-boat's paint was far from fresh, and had sustained a reasonable degree of weathering. The starboard side of the conning tower had numerous patches of a darker paint where the rust had been treated and painted over. This may have been red lead undercoat, or a grey paint. In contrast, the port side of the conning tower was adorned with several patches of rust, and seems not to have been touched up with the darker paint. One might assume that both sides of the conning tower would have been treated at the same time, but apparently this had not been the case. There was also one large patch of a darker colour on the top of the starboard hull casing, just above the starboard saddle tank, which may also have been red lead undercoat or dark grey paint.

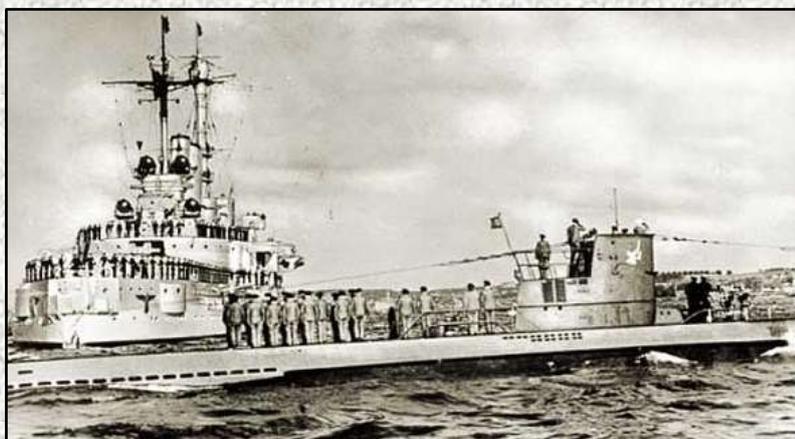
Left (12): On the 23rd October, U 47 sailed past numerous battleships and cruisers moored in Kiel to celebrate the Scapa Flow mission. Crews of the *Scharnhorst*, *Emden* and the training ship *Schleswig-Holstein* paraded on deck in honour of the little U 47. This photo shows U 47 sailing past the training ship *Schleswig-Holstein*.

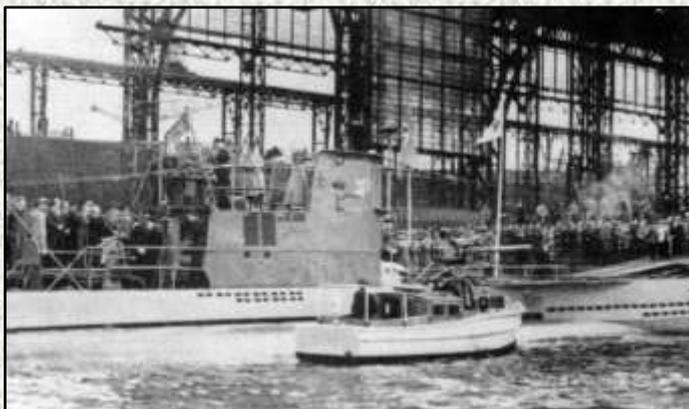
Right (13): U 47 enters the *Germaniawerft* shipyards on the 24th October 1939. The patchy appearance of the tower is apparent. Note also that the mount for the 20mm Flak gun was on the aft deck at this stage.

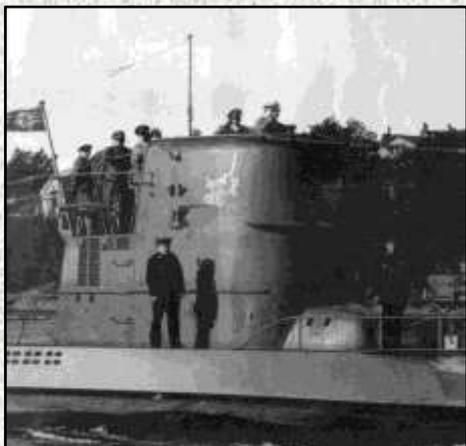
Left (14): Rust streaks can be seen on the dark grey *Schiffsbodenfarbe III Grau* saddle tanks. Note also the starboard breakwater at the right hand side, and the spray deflector midway up the front of the tower. Both these features were added at some stage before October 1939.

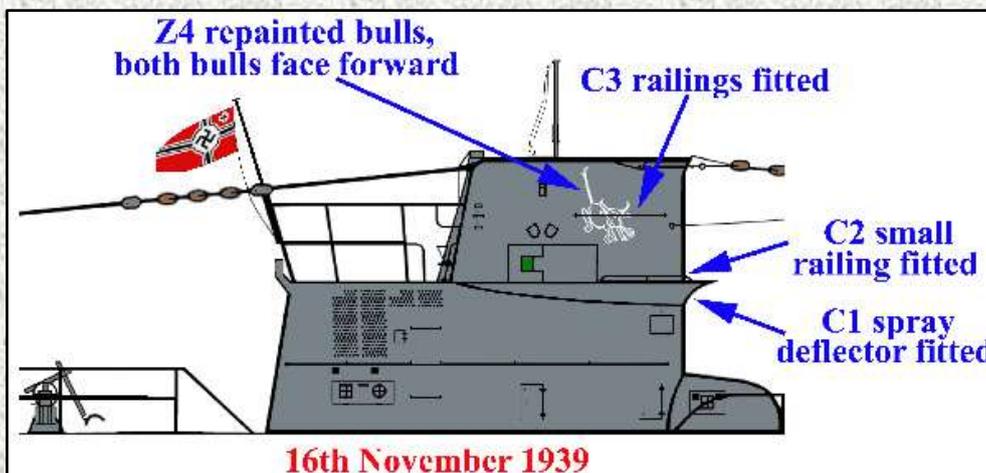
Below (15): U 47's conning tower on the 16th November 1939, with the extended spray deflector. From that date onwards the bulls both faced forward rather than both facing to the left.

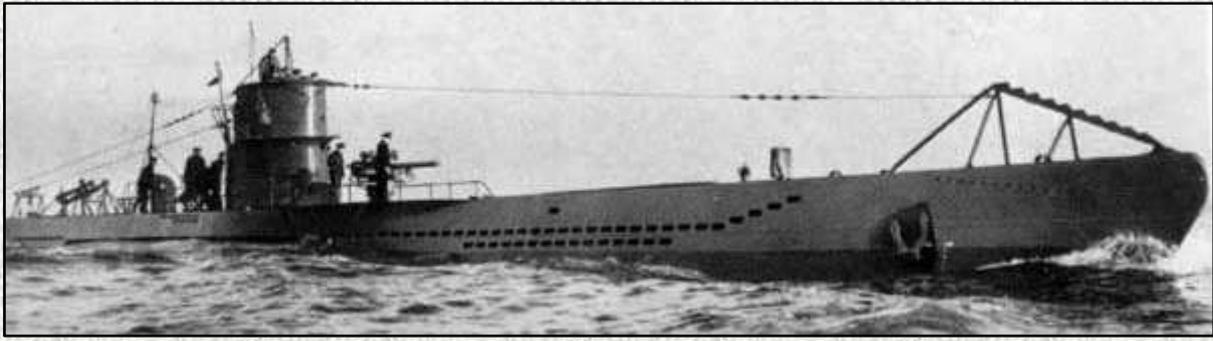
Above (16): The extended spray deflector can be discerned in this photo of U 47, taken before her 3rd patrol commenced on the 16th November 1939.

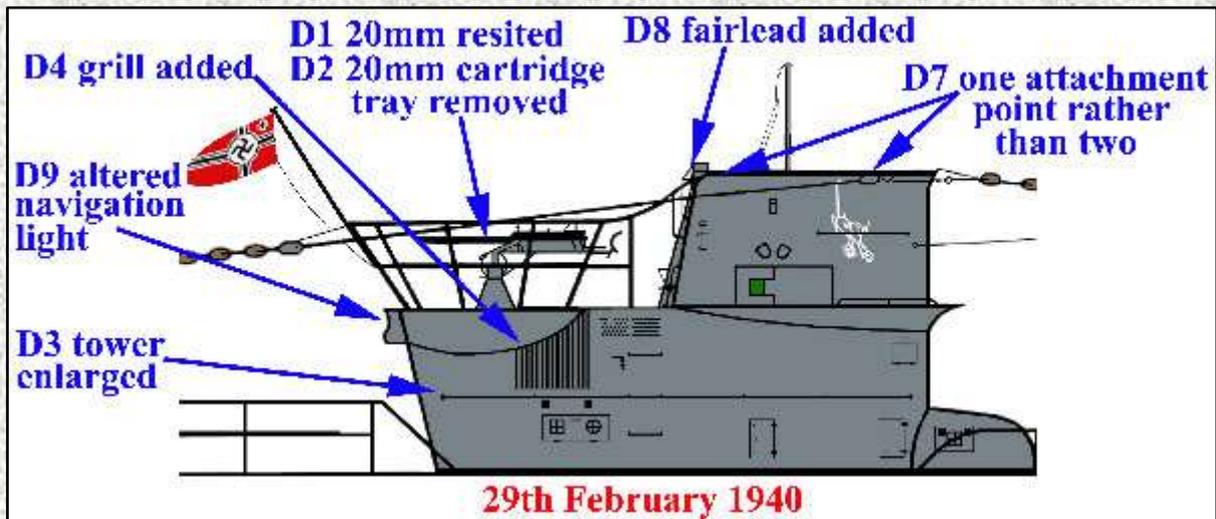
Above (17): U 47's newly-modified tower on the 29th February 1940.

The rear of U 47's conning tower was greatly enlarged to accommodate the 20mm (D3). The railings curved around in a circular shape to follow the much-wider circular-shaped tower floor.

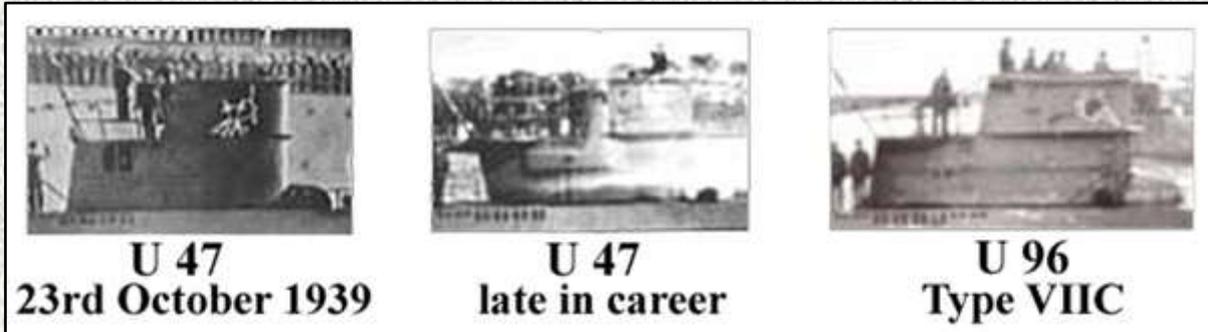
Above (18): These images show how the angle of the trailing edge of U 47's conning tower changed in the December 1939 - February 1940 refit. Comparisons in this area can be made between U 47 on the 23rd October 1939, U 47 late in her career, and the famous Type VIIC U 96.

Since the rear of the tower was significantly larger than before, the rearmost vertical railing stanchion was located farther aft than it had been earlier. It was so much farther aft that the trailing edge of U 47's new tower sloped in the opposite direction than before. Also, the angle of the trailing edge of U 47's new tower was the opposite to the angle of the trailing edge of early VIIC towers. In fact, the angle of the trailing edge is one noticeable external difference that allows us to differentiate between a VIIB (with the 20mm on the rear of the tower) and a VIIC.

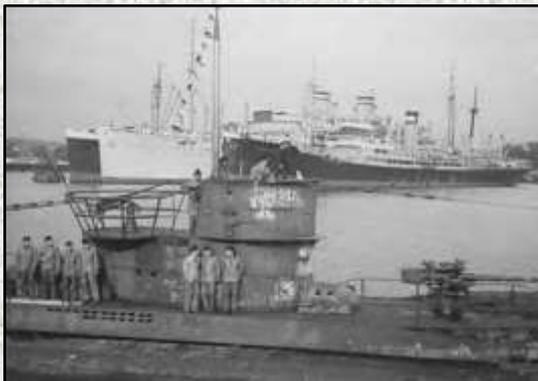
Above left (19): Taken on the 6th July 1940, this image clearly shows U 47's modified tower, with the 20mm on the rear of the tower.

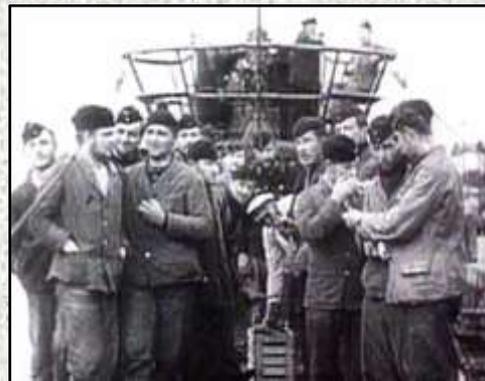
Above right (20): Another 6th July image, this photo illustrates how the new tower railings protruded out much farther than the old style tower railings.

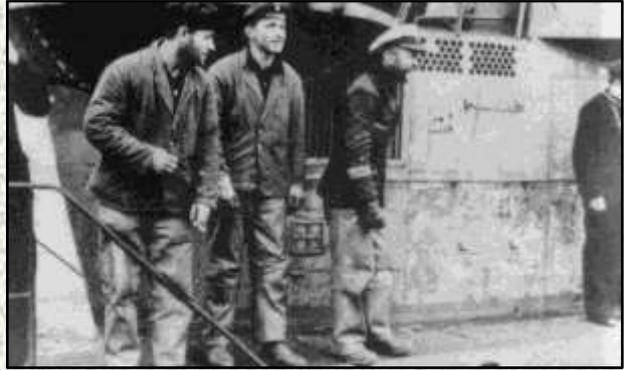
Right (21): The grill with vertical bars can be seen behind the boat's laughing commander Prien in this 6th July 1940 photo.

A grill was added on the starboard side, beneath the front of the round area of the tower floor (D4). The addition of the 20mm to the tower resulted in some of the ventilation holes on the starboard side being blocked over, so a grill with vertical bars was chosen as a replacement for the

holes in this area. This allowed just as much, if not more, air to be accessed by the diesel intakes. A similar grill was **not** in place on the port side. On the port side, the addition of the 20mm to the tower reduced the number of circular intake holes.

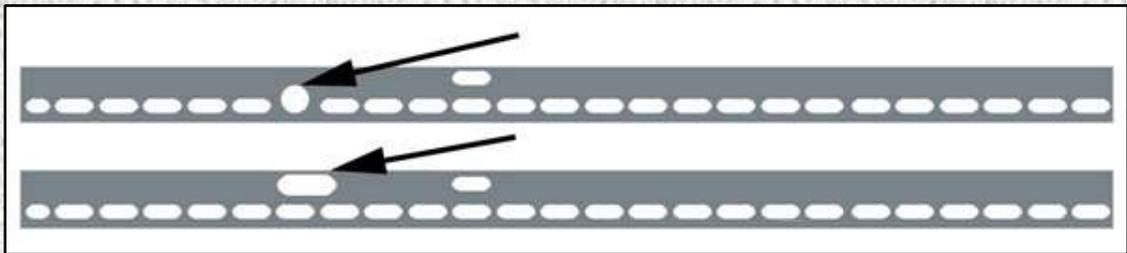
Above (22): Above is a comparison which shows how the diesel exhaust outlets were modified.

At some stage both diesel exhaust outlets were modified from being round in shape (along the aft drainage holes) to being oval in shape (above the level of the aft drainage holes) (F3). This may have occurred during this refit or the previous one.

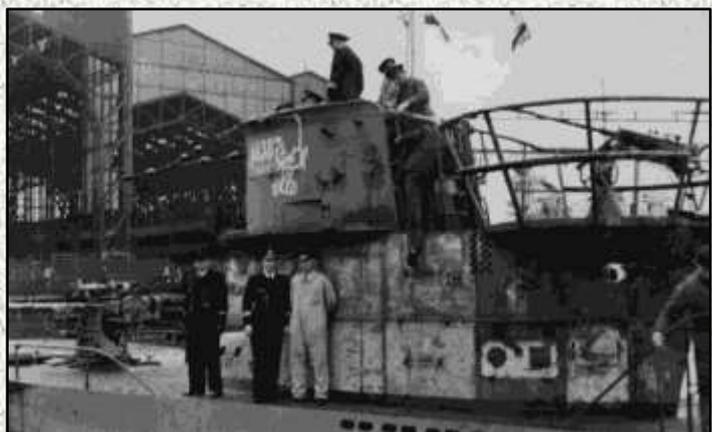
Above (23): U 47 is about to enter the *Germaniawerft* shipyards in Kiel on the 8th July 1940. The heavy weathering is clearly evident in this photo.

When U 47 returned to Kiel from the very successful sixth patrol on the 6th July 1940, the boat was very heavily weathered, with patches of the undercoat showing through in places. When U-boats were subjected to heavy weathering, their top layer of paint would peel off in patches. The older paint, or even the red or grey primer, that was beneath the top layer would be revealed. The first area for this to occur in was often the bow. The older bull had been painted over with a patch of *Dunkelgrau 51* paint. Then a fresh version of the snorting bull was added on top of the patch.

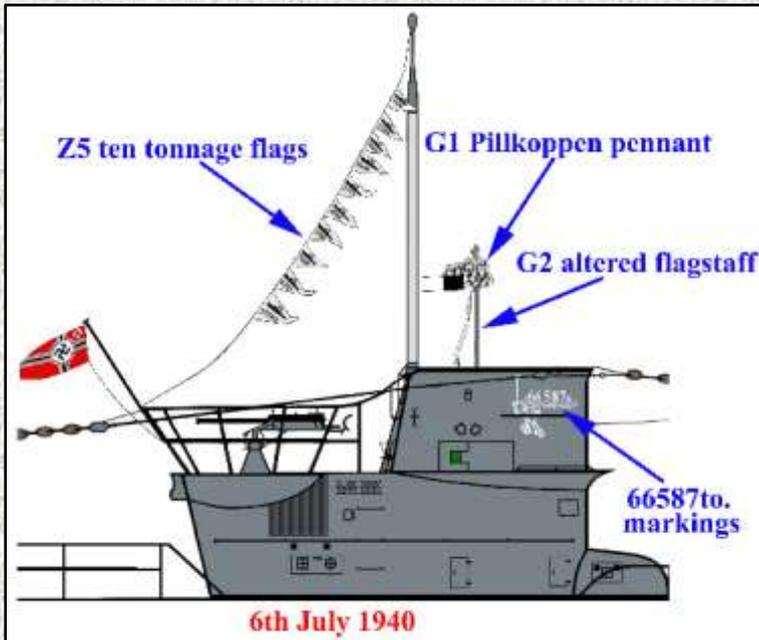
Left (24): U 47 had ten victory pennant flags (*erfolgswimpeln*) flying from the attack periscope on the 6th July 1940.

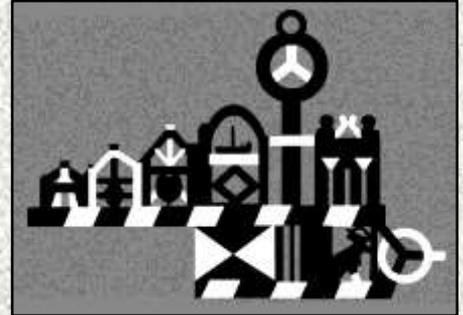
Below (25): A drawing of the Pillkoppen pennant.

The Pillkoppen pennant on U 47 was associated with Pillkoppen (today Pilkopiai in Lithuania), a fishing village on the Kurische Nehrung (Curonian Spit). The Kurische Nehrung is a spit of land 100km long which lies on the coast of the Baltic Sea, just to the west of Lithuania. Several of the fishing villages on the Kurische Nehrung had decorative flags. Prior to 1844 these flags had been merely decorative, but during this year an order was given to use these flags to identify which village a fishing boat belonged to. The recognition sign was a flag half a metre long, and it was attached to an elaborate woodcarving. Each fishing village had its own combination of black and white colours. The Pillkoppen decoration consisted of two white triangles with their points facing towards each other on a black rectangular background.

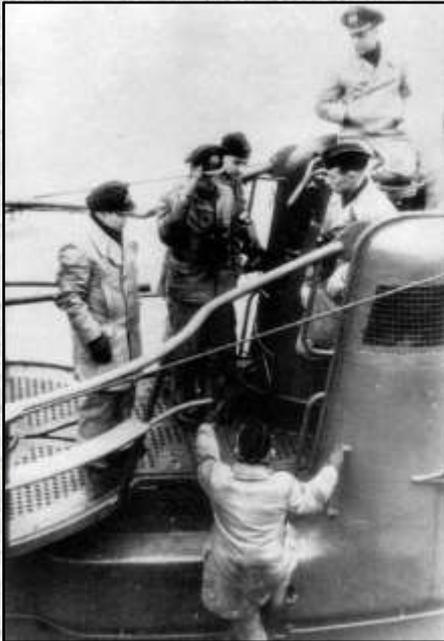
Above left (26): The large air trunk on the starboard side (another was present on the port side) and the grill are apparent in this 3rd November 1940 image of U 47. The pattern of the square drainage holes on the floor of the tower are also noteworthy since they cannot usually be seen in most photos.

The most notable addition during this refit was the fitting of air trunks (H1). In original VIIs (also known as VIIAs) and VIIBs such as U 47, the supply of air to the diesel engines was poor. The main trunk providing air to the diesels was routed forward under the rear deck casing and up inside the after end of the tower. Ventilation holes to let air into the intake trunk were located on the after sides of the tower wall, primarily on the starboard side, and these were susceptible to interruption in high seas. To rectify this problem, during this refit large external L-shaped trunks were built up **both** sides of the tower, starting from the rear of the tower and extending up the after edge of the conning tower bulwarks.

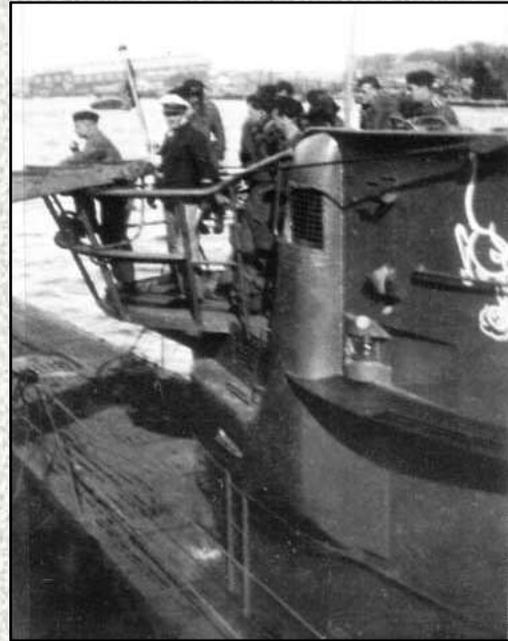
Above right (27): The darker grey colour and the air trunking can be seen on U 47's conning tower in this photo. The spray deflector, being a horizontal surface, was painted black.

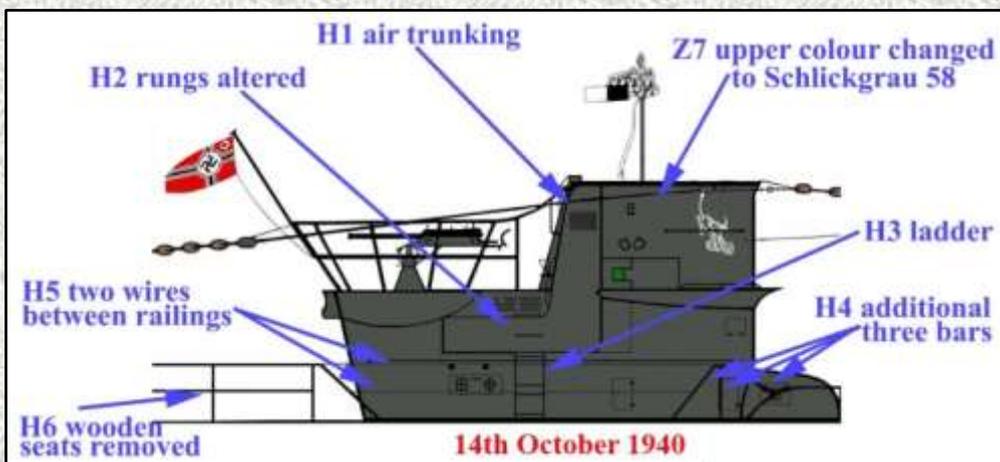
Below (28): The tower of U 47 in late 1940, with air trunking on both sides and *Schlickgrau 58* paint.

- rungs were added on top of air trunks (H2).
- a short ladder was fitted between the two air trunks and the deck (H3).
- an additional three bars, in a triangular shape, were added to the forward deck railings (H4).
- in order to help prevent crewmembers from falling overboard, two wires were added per side from the forward deck railings to the aft deck railings (H5).
- the wooden seats on the aft deck railings were removed, leaving only the supports remaining (H6).

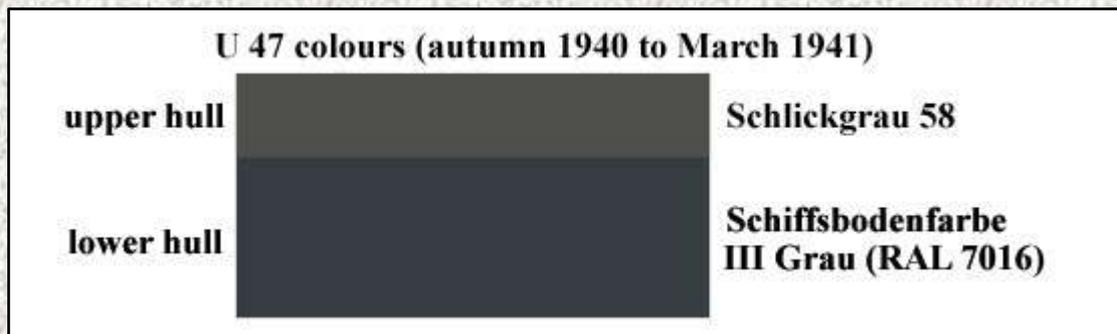
Below (29): The upper colour of U 47 from the September/October 1940 refit until the boat's demise in March 1941 may have been *Schlickgrau 58*.

The upper hull and conning tower of U 47 remained in this shade of grey thereafter.

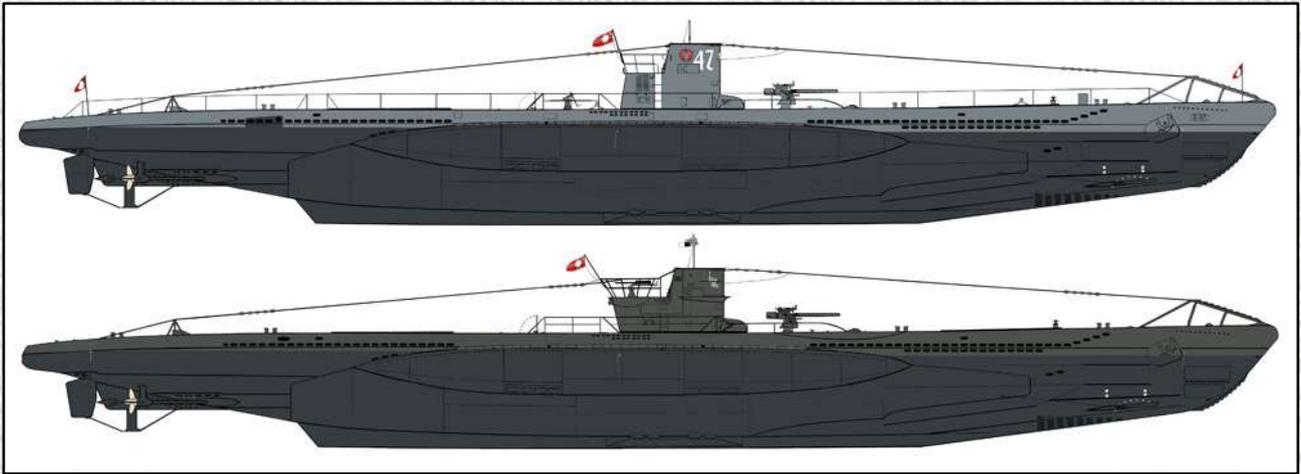
Above (30): U 47 at the start and end of her career, with the lower hull paint being *Schiffsbodenfarbe III Grau* (RAL7016).

The March 1940, November 1941 and July 1944 editions of these painting regulations all state that the external sections of the lower hull were to be painted with two coats of anti-corrosion paint followed by two coats of the anti-fouling dark grey paint *Schiffsbodenfarbe III Grau* (RAL7016, in between FS36076 and FS35042). This is the paint that was likely to have been used upon the lower hull of U 47.

The black bootline seen in some drawings and upon some models is definitely erroneous as there are no photographs in common circulation showing any Kriegsmarine U-boats with a bootline. A good quality photo of U 47 being launched shows that the U-boat certainly did not have a bootline.

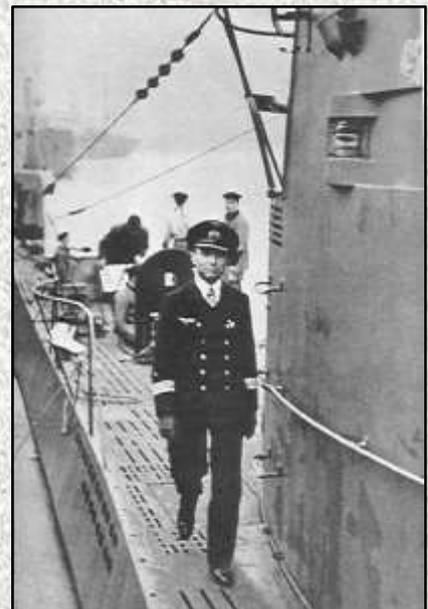
Below right (31): In this photo, taken in Kiel in late October 1939, it can be seen that the area under Prien's feet has worn more heavily than other areas that were not walked upon as frequently. The areas of heavier wear would have been slightly browner.

The March 1940, November 1941 and July 1944 editions of *Allgemeine Baubestimmungen Nr.31* (building regulations form Nr. 31) all state that the wooden deck was treated with a black wood preservative (*Teerfirnis Tf 99*). A U-boat deck started out as jet black in colour then quickly became charcoal in colour. As it was exposed to the elements, the deck developed a brown tinge. The more the deck was subjected to weathering, the lighter and browner it became. On the surfaces that were frequently walked upon, the wood preservative would wear more heavily and reveal more of the natural wood beneath. The deck would also become bleached by saltwater and the sun, causing small patches of white to appear. If a U-boat had not been serviced for many months, green algae would start to grow on the deck. As this plantlife was slippery, and therefore hazardous to the sailors walking on deck, the algae would not have been allowed to accumulate. It would have been removed before any serious built up took place.

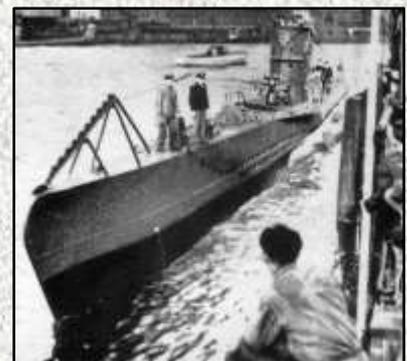
Right (33): The front set of waterline draught numerals on the port side stand out in this late October 1939 photo of U 47.

Depth markings - Three sets of waterline draught marking numerals were marked upon both sides of the hull. These small white numerals were aligned vertically. The top numeral, 9, started roughly at the division between the two greys, and the markings continued down the hull to the bottom numeral, 0. They were situated a few feet aft of the bow, on the saddle tanks, and a few feet forward of the stern.

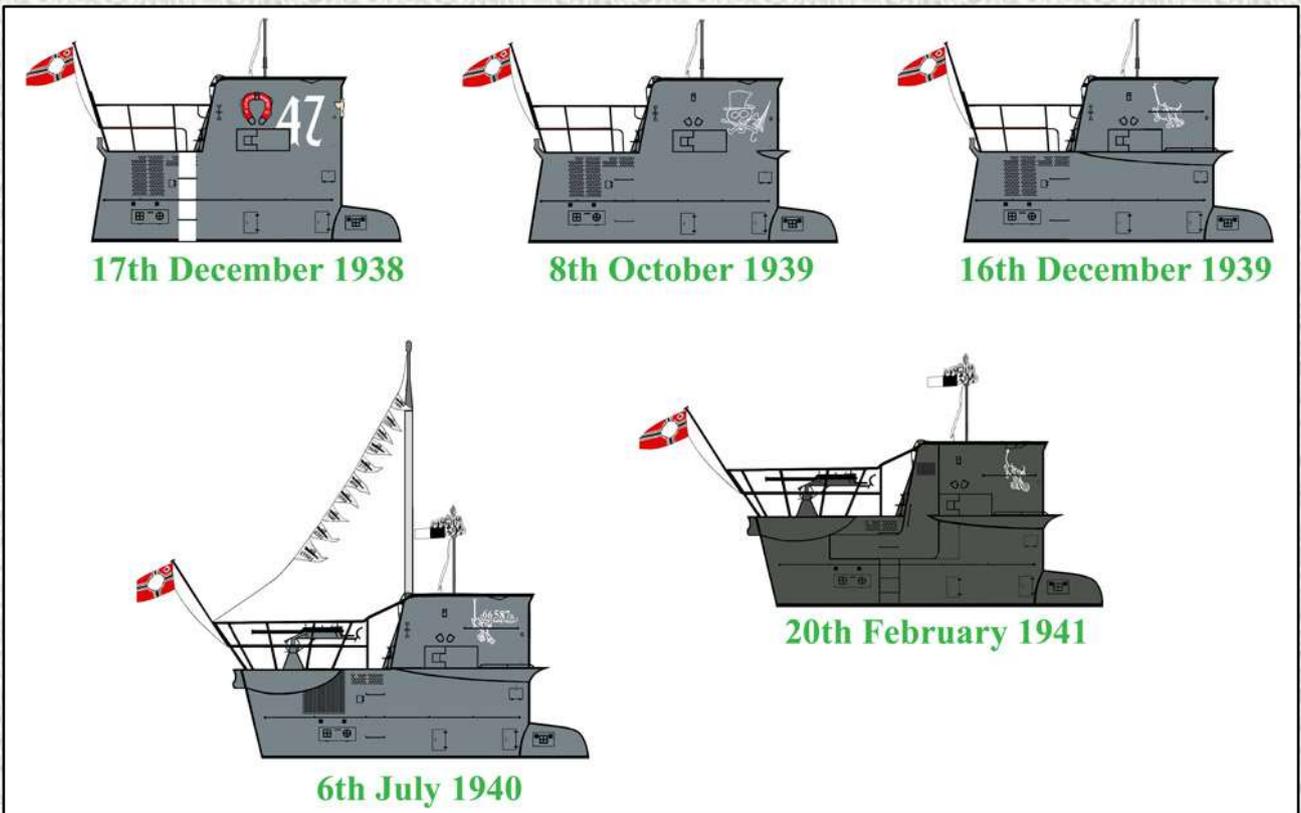
Above (34): A comparison of the towers over the course of U 47's career.

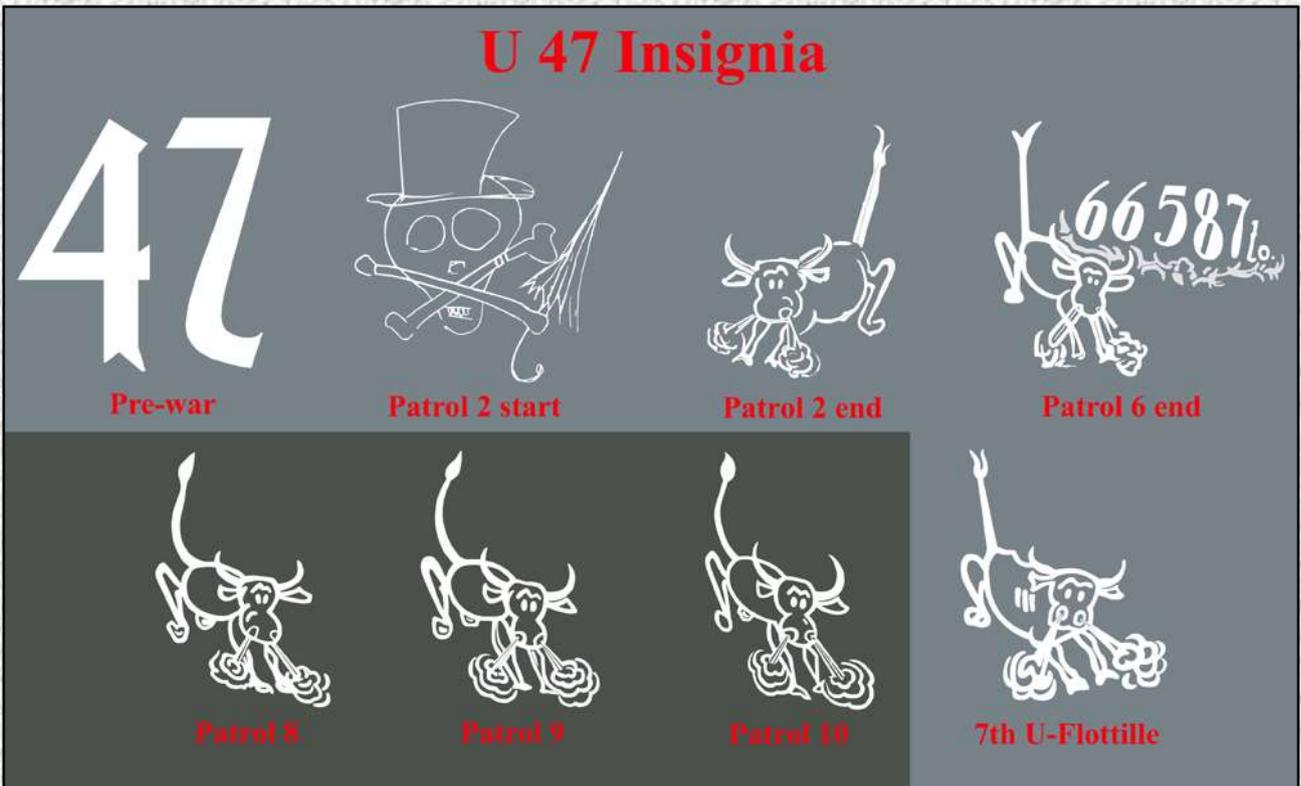
Below (35): The insignia on the towers of U 47.
